A closer look at TS1 LO.

Discoveries & differences
found during restoration of TS1.

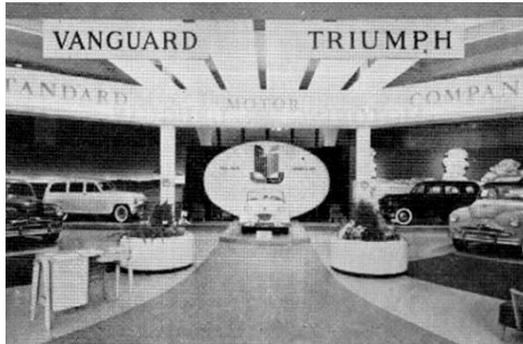
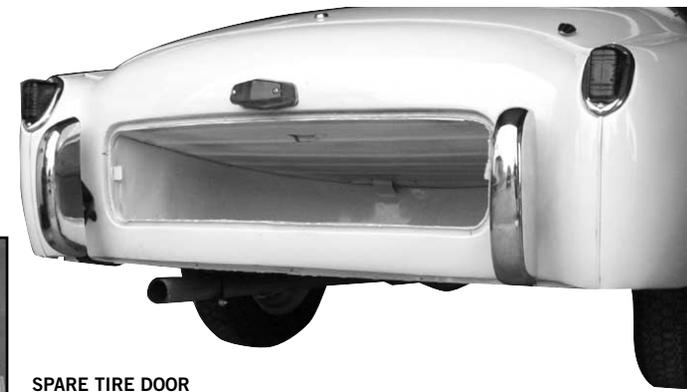
SPARE TIRE DOOR

TS1 has a more narrow spare tire door, made from aluminum and not embossed with license plate area. This was a recall item for the first 30 or so cars (or until wire wheels were introduced as an option). TS1's door configuration did not accommodate a wire wheel so later cars have taller doors and frame modifications.

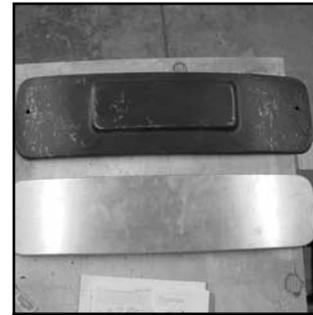
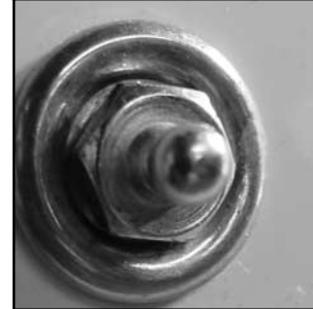
BABY TENAX

These original baby fasteners were re-chromed and finish washers were machined to match the original washers.

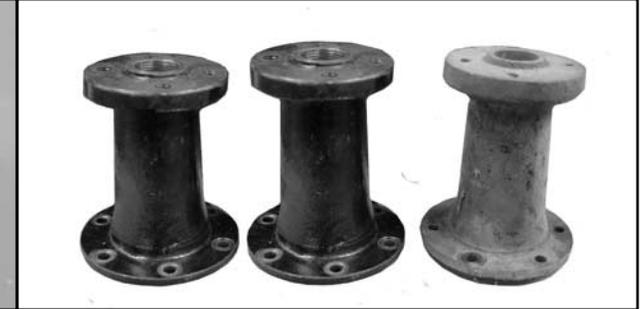
FAN SPINDLES

When it came time to install the radiator to TS1, it was found that TS1's fan spindle was shorter than other TR2 spindles. It was known that early TR2s used a shorter spindle than later ones, but TS1's spindle was even shorter.

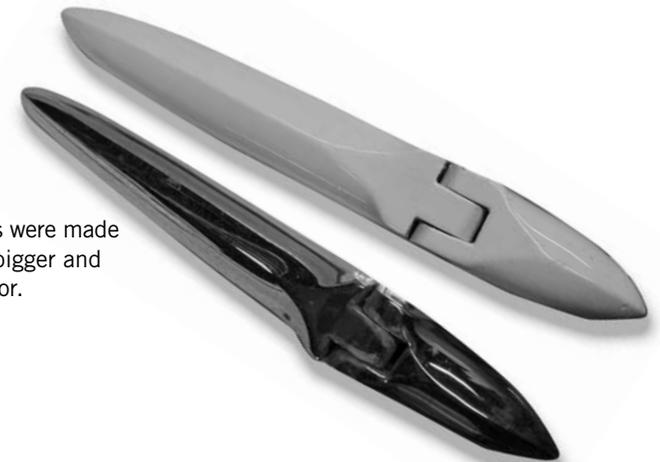
HINGES

Bonnet and boot hinges were made from brass, they were bigger and painted the bonnet color.

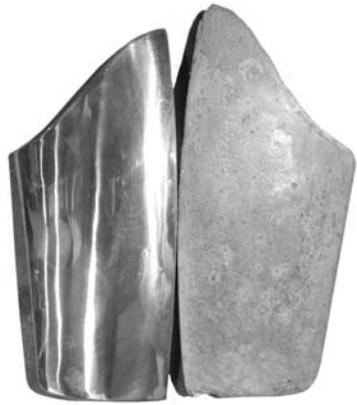
STONE GUARDS

TS1's stone guards are larger and wider and more round to accommodate rounder, wider rear fenders.

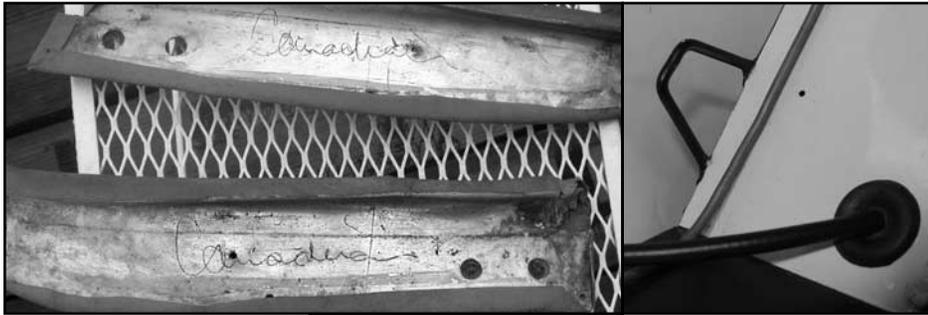
DOOR CAPPINGS

Discovered on the underside, marked "Canadian" for TS1, designating parts for car going to Toronto car show. (remember they were building TS2 at the same time side by side)

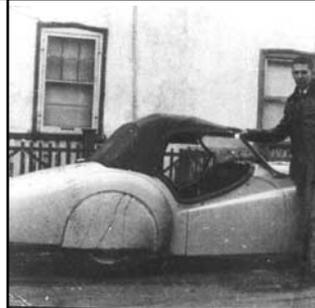
REAR FENDER WINGS

Rear fenders were hand-formed wider and more round on the edges than square, like later TR2s.

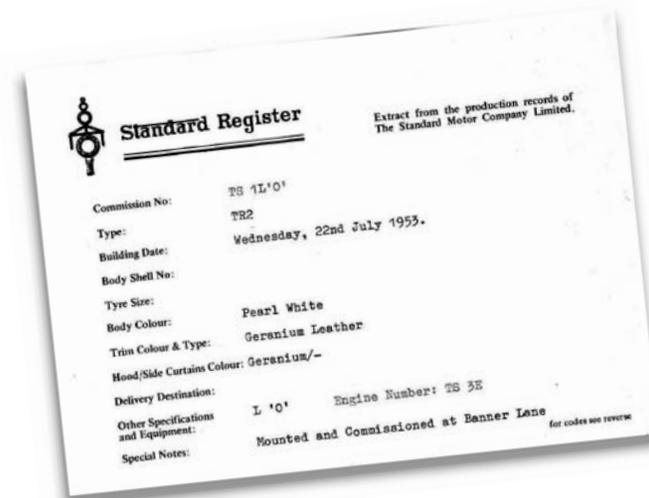
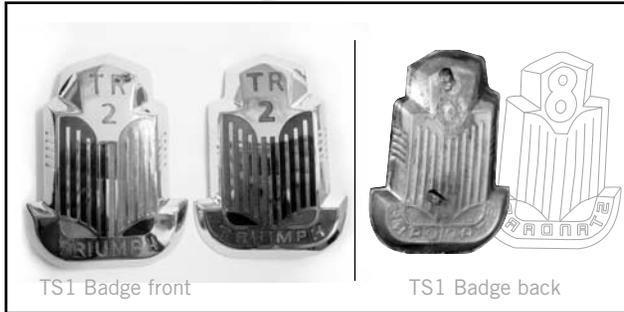
APRON MEDALLION

At first glance, TS1's badge doesn't look that different, the badge is definitely larger and heavier in your hand. But to notice the real secrets of the badge you have to turn it over and examine the backside (see photo and illustration on upper right). On the backside of the medallion you would see that the badge was constructed from a Standard 8 badge pieced together and re-enameled to resemble a TR2 badge design as we know today.

The colors on the badge are reversed (black field and red field) in the open book area. Also, the area with the word Triumph is not enameled with a red background. This medallion was truly the "first prototype" for the TR2 badges as we know them today.

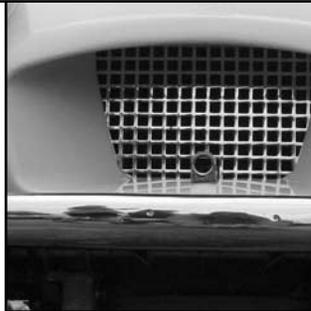
TS1 FRONT GRILL

The grill on TS1 is cast out of brass, as well as, the sidecurtian door brackets and sidecurtain frame wedges, as opposed to being made from aluminum like later TR2s.

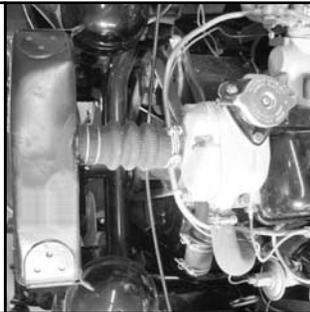
THERMOSTAT HOUSING

This item was one of the early design changes made through a recall for the first 1,201 TR2s. This service recall replaced the radiator with a long fill neck. If you look closely TS1 is fitted with a radiator that does not have a fill neck, rather it has a fill cap that is located on the thermostat housing, just as it would have appeared prior to the service recall.

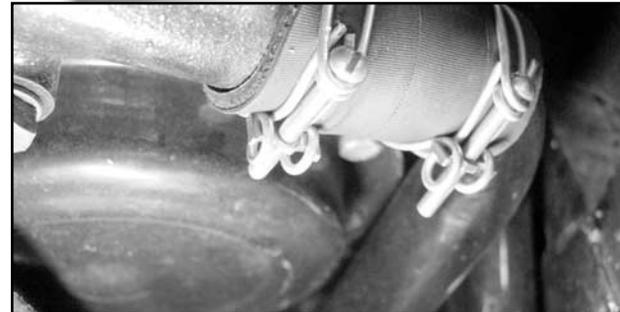
RADIATOR LOWER PIPE

(water tube) This configuration is slightly different than other TR2s, the piping run is made mostly of curved metal and short straight hoses, rather than, the near straight metal pipe and curved hoses used in later TRs.

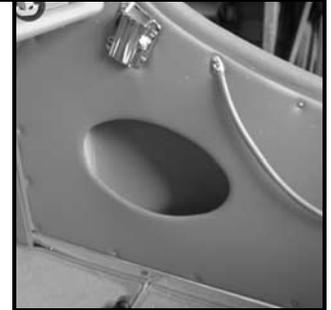
INTERIOR DIFFERENCES

Oval Door pockets
 Seat Frames and springs

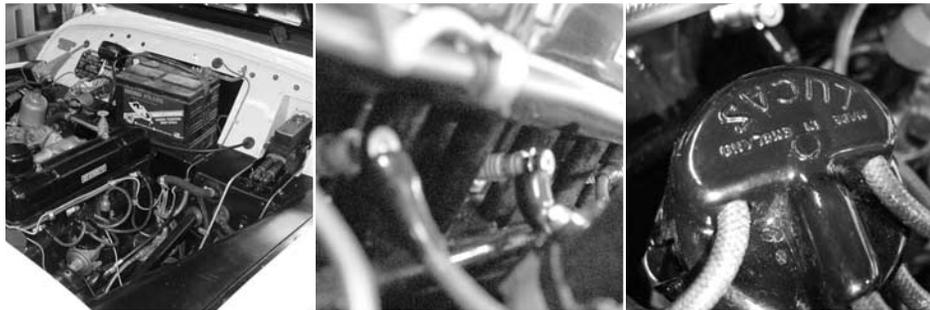
TS1 FINAL PAINT FINISHES...

Take a close look at the engine compartment upper bulkhead, you will notice that it was painted a more platinum version of white, the car at some point, before completion, was resprayed pearl white, and thus the engine compartment was sprayed out in the flat black to mask the color changes. These paint changes though subtle, are visible in historical photos and the paint was replicated from saved pieces and matched as accurately as possible.

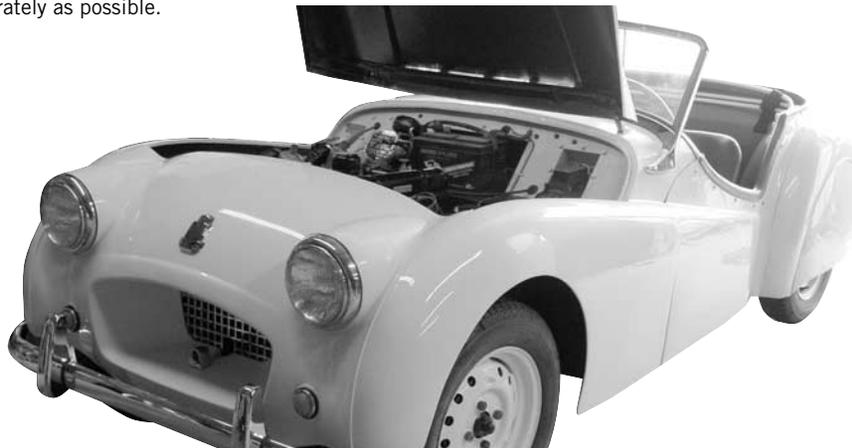
DISTRIBUTOR CAP

Distributor cap notice the direction of the imprinted LUCAS type.... these caps seem to be original to very early TR2s.

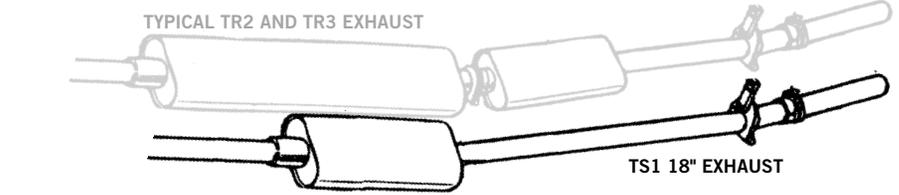
18" MUFFLER

This muffler and exhaust system was originally designed for the high audible noise level generally accepted for this type of vehicle, in order to keep the loss of horsepower to a minimum.

The exhaust system was also the victim of a Triumph Service Recall, for many of the early TR2s. The 18" mufflers were replaced with a 24" muffler silencing the cars and lower their horsepower. TS1 has been refitted with the 18" exhaust keeping it original to 1953 prior to the recall.
